## TEST REPORT

Report No. : TH70144A/2014

Product Description: Multi-Purpose Rail

Test Requested: Static Load Test

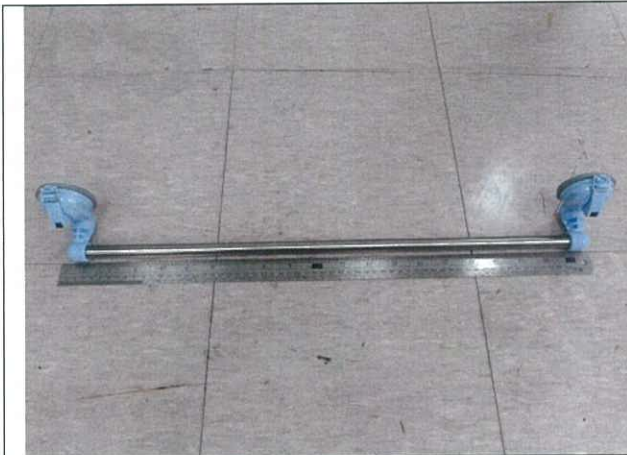
Photo “A” Appearance of sample: 9416601

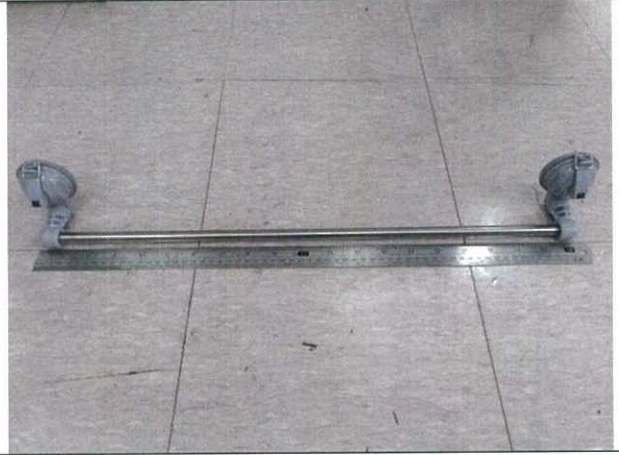
Photo “B” Appearance of sample: 9413601

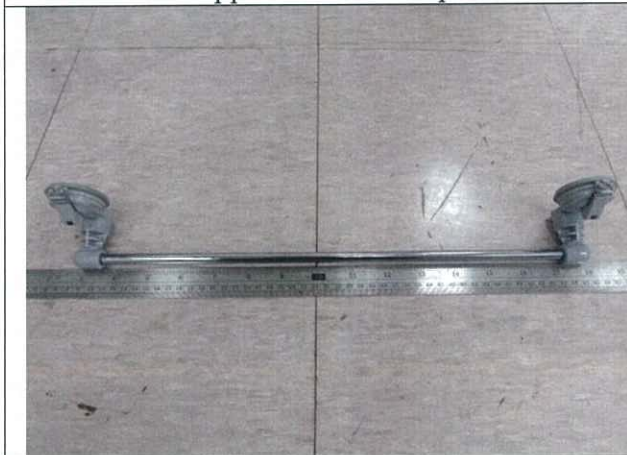
Photo “C” Appearance of sample: 9410451

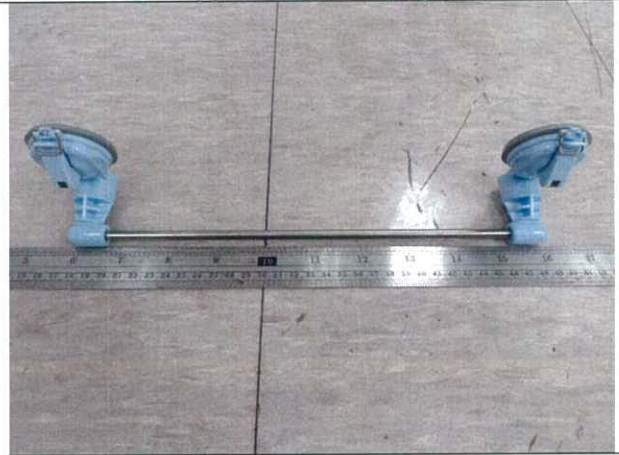
Photo “D” Appearance of sample: 9406301

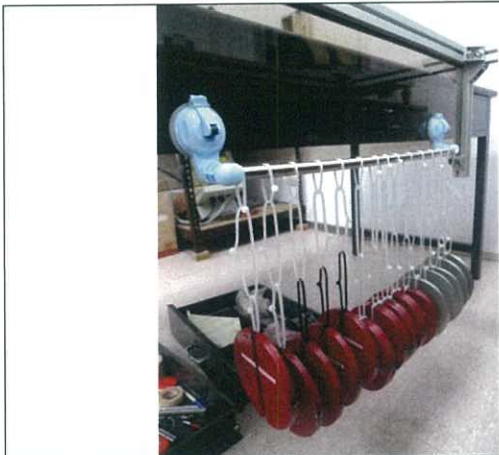
Photo "E" Static Load Test: 9416601

- Test Method:
- a. Secure the sample on the testing glass.
  - b. Suspension specific weight evenly on the sample and maintained for 168 hours.
  - c. Visually check and record if the sample dropped or not after testing.
- Note. 1. Test weight requested by the applicant.  
 2. Test environment: Temperature: 20±2 °C; Humidity:60±10%.

Sample	Sample No	Test weight (kg)	Observation
Multi-Purpose Rail	9416601	20	The sample didn't drop after testing.
	9413601	15	The sample didn't drop after testing.
	9410451	10	The sample didn't drop after testing.
	9406301	5	The sample didn't drop after testing.

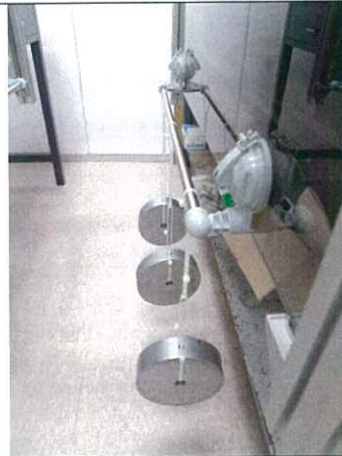
Photo "F" Static Load Test: 9413601

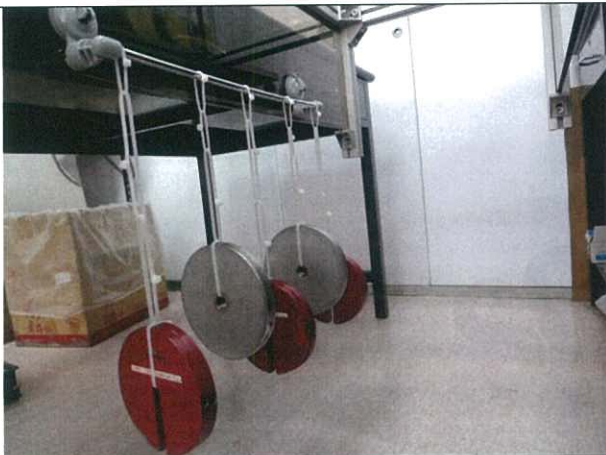
Photo "G" Static Load Test: 9410451

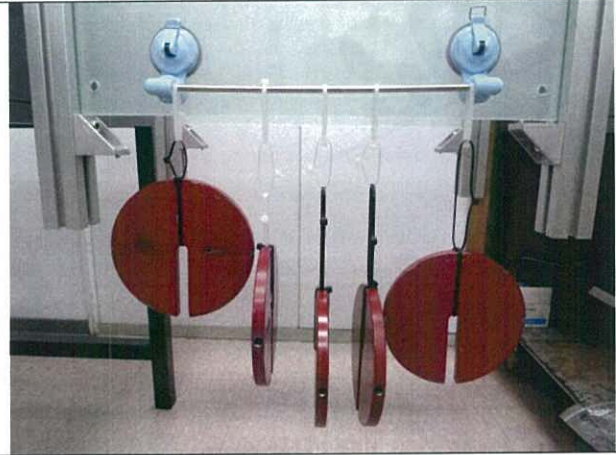
Photo "H" Static Load Test: 9406301
