TEST REPORT

Report No.: TH60066A/2014
 Page: 1 of 2
 Date: JUL. 10, 2014

Product Description: Suction Hook
Style/Item No.: 9430080
 9440080
 9430068
 9430051
Country of Origin: TAIWAN

Test Requested: Static Load Test

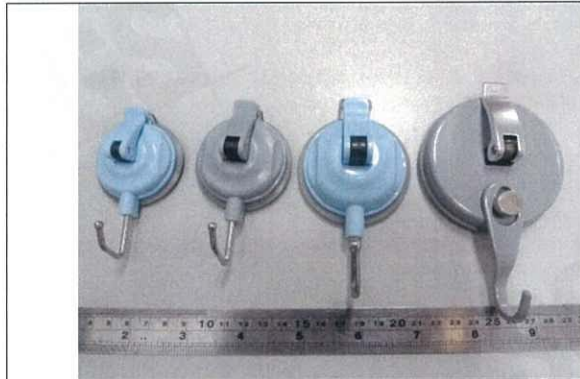
Photo "A" Appearance of sample

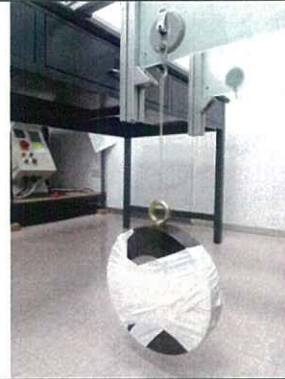
Photo "B" Static Load Test: 9430080

Sample	Sample No	Test weight (kg)	Observation
Suction Hook	9430080	22	The sample didn't drop after testing.
	9440080	14	The sample didn't drop after testing.
	9430068	10	The sample didn't drop after testing.
	9430051	6	The sample didn't drop after testing.

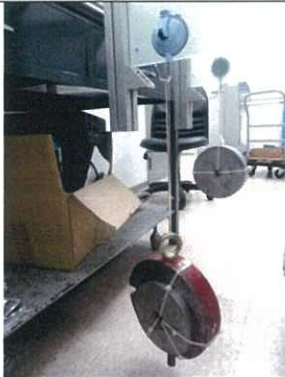
Photo "C" Static Load Test: 9440080

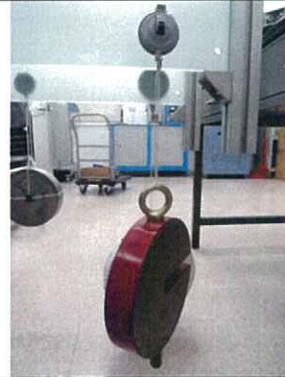
Photo "D" Static Load Test: 9430068

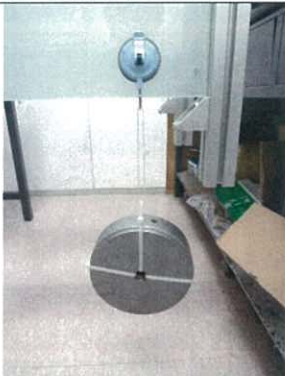
Photo "E" Static Load Test: 9430051
